Dedication of Blue Book

CAPITOL RESTORATION

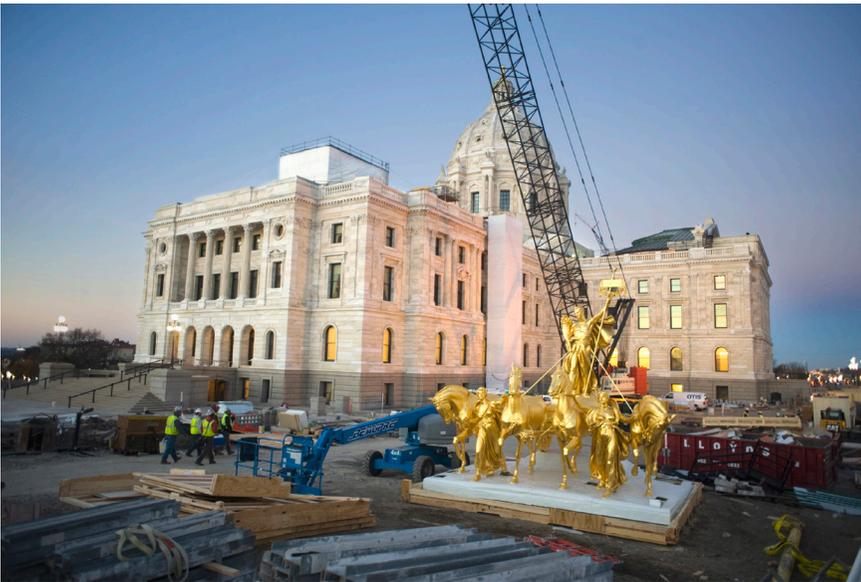
On May 7, 2016, a 300-ton crane lifted the Quadriga from the roof of the Minnesota State Capitol in order to allow for roofing repairs below. The statues were taken off-site to a nearby warehouse in town where artisans re-gilded the sculpture with 30,000 individual sheets of 23 karat gold leaf, sourced from Italy. Re-gilding is necessary approximately every 20 years. The photo above was taken on November 12, 2016 just before the Quadriga was re-installed on the roof of the Minnesota State Capitol.

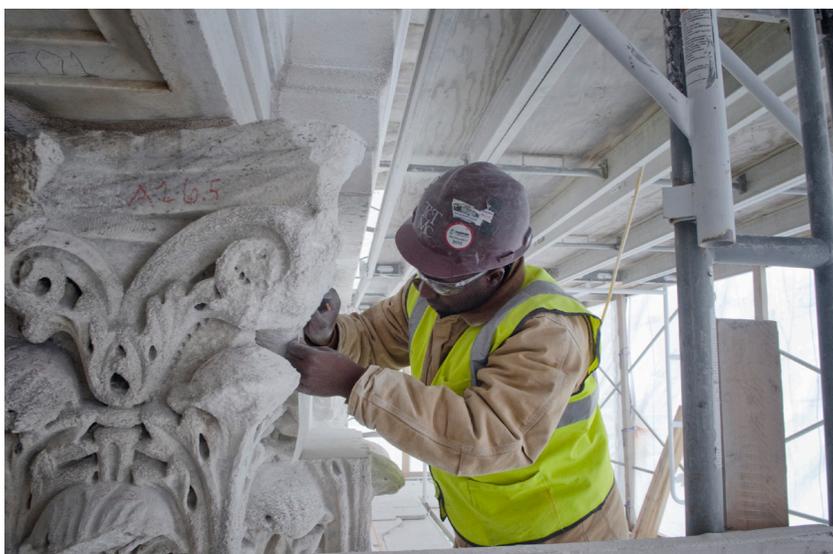
Every piece of Georgia marble on the Capitol was evaluated by the design team to determine appropriate repairs. Every stone was cleaned and re-pointed, and many were resurfaced to remove deterioration. Where the deterioration was too extensive, dutchman repairs (replacing part of the deteriorated carved or cut stone with a new piece) were completed. Dutchman replacement stone was carefully fabricated, installed, and blended with the adjacent stone. The stone came from a quarry in Georgia near the same location as the original stone. These repairs were needed after 110 years of exposure to the Minnesota elements including the freeze/thaw cycle. The top photo shows one of the six sculptures done by famous sculptor Daniel Chester French.

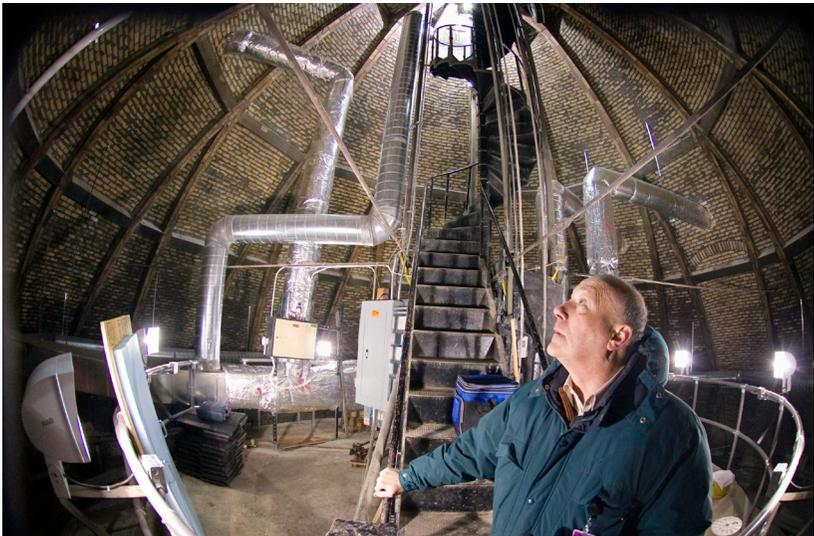
The Capitol has three domes, an inner masonry decorative dome, which can be seen from inside the Rotunda; a steel and brick (pictured here from the inside) middle dome that holds up the exterior lantern and gold finial on the top of the building, and a third dome of Georgia marble on the outside. Each is independent of one another. The exterior dome is the second largest self-supporting marble dome in the world.

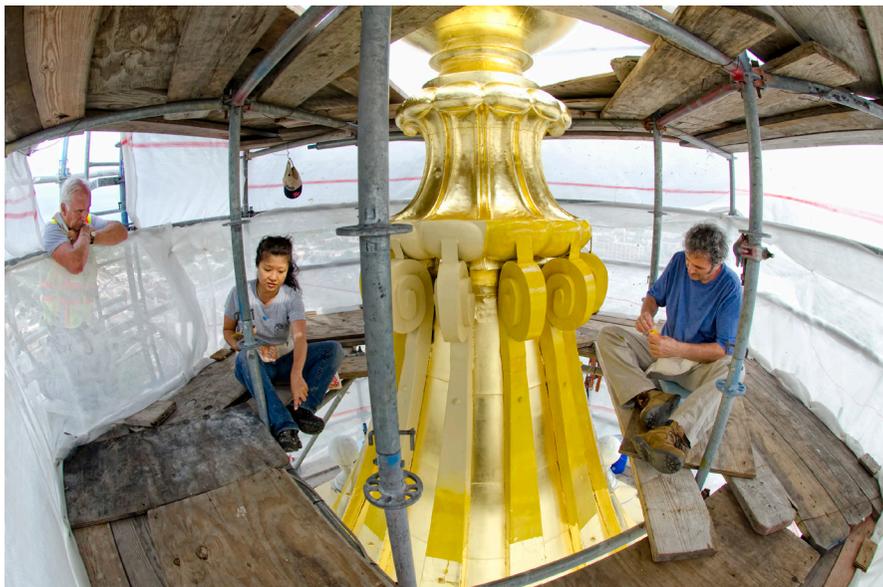
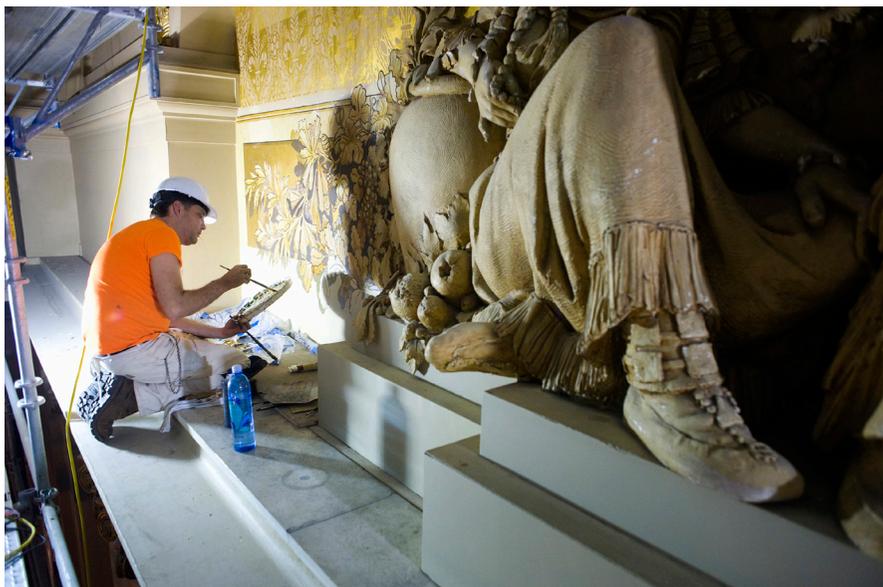
The finial at the very top of the building is supported by a masonry “middle dome” that is not visible from the outside. The top photo shows a close up of the finial as it was re-gilded in 2011.

Restoration, repair, and conservation work was completed on decorative art (paint applied directly on plaster - mostly stencil work) and fine art (artwork painted on canvas) in the Capitol. The bottom photograph shows a decorative painter applying final touches to the decorations next to the large statuary group on the north wall of the House Chamber.

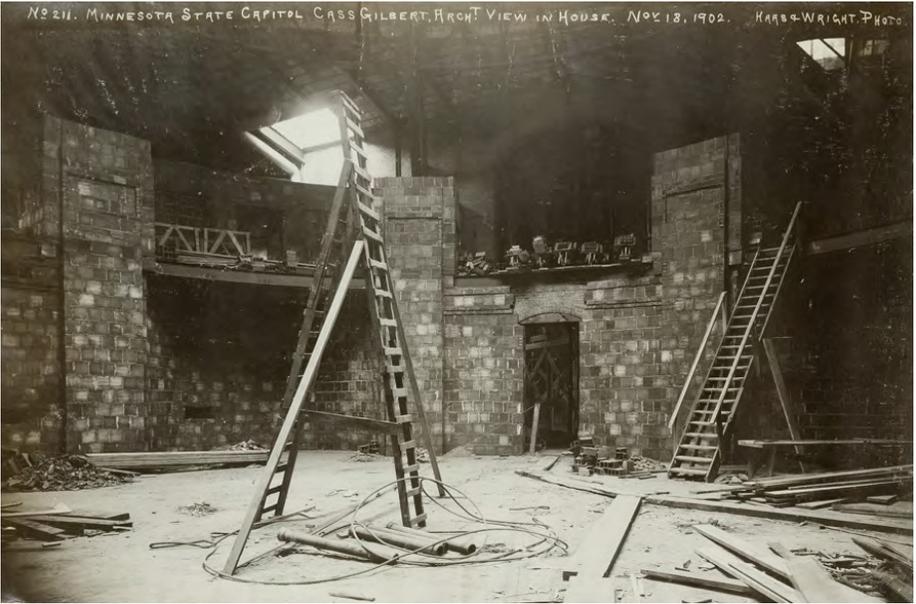
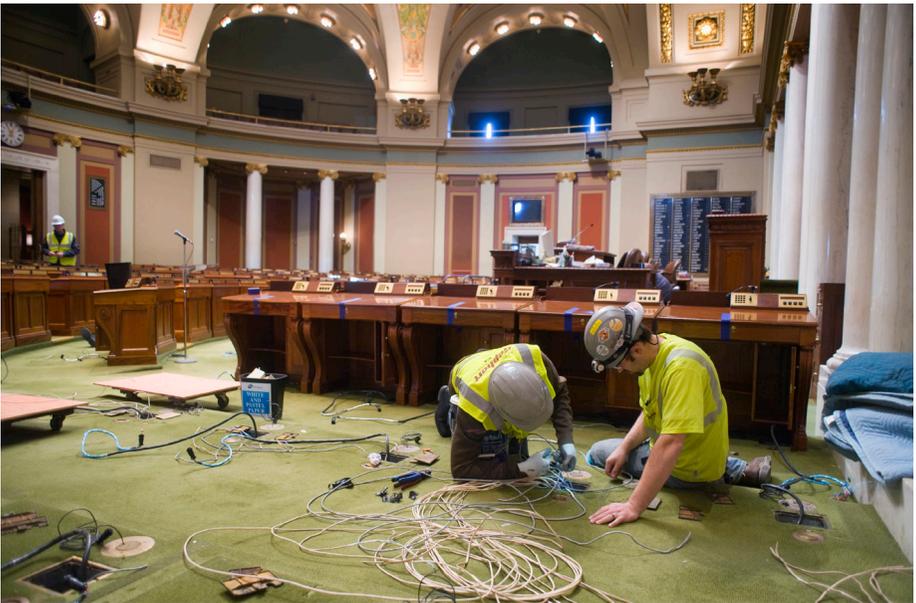
This view of the House Chamber (top) in 1902 shows the block and clay tile walls before plaster was applied to finish the room. The open spaces at the top of the walls are where the public galleries were placed.

New electrical, phone, internet, and voting system cabling was installed for the members' desks in the House Chamber as part of technology upgrades. New carpet was fabricated to replicate historically correct patterns and colors.

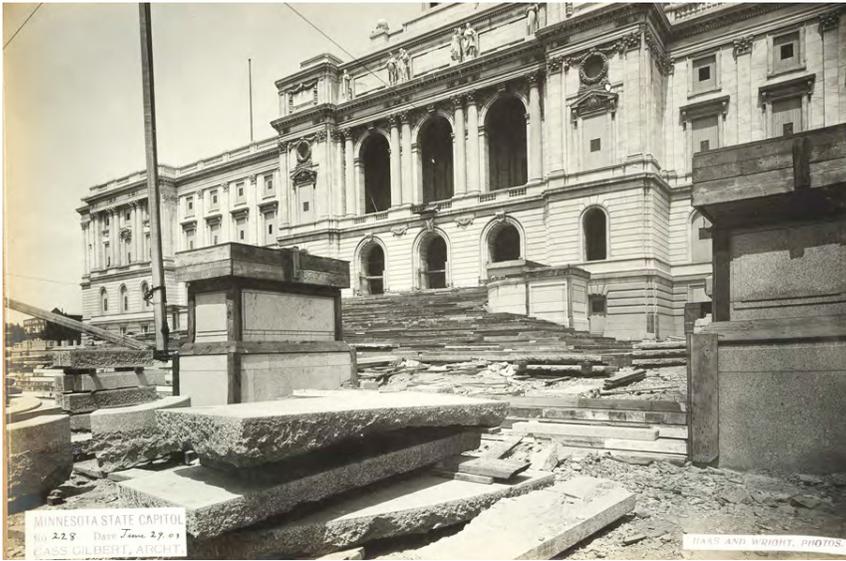
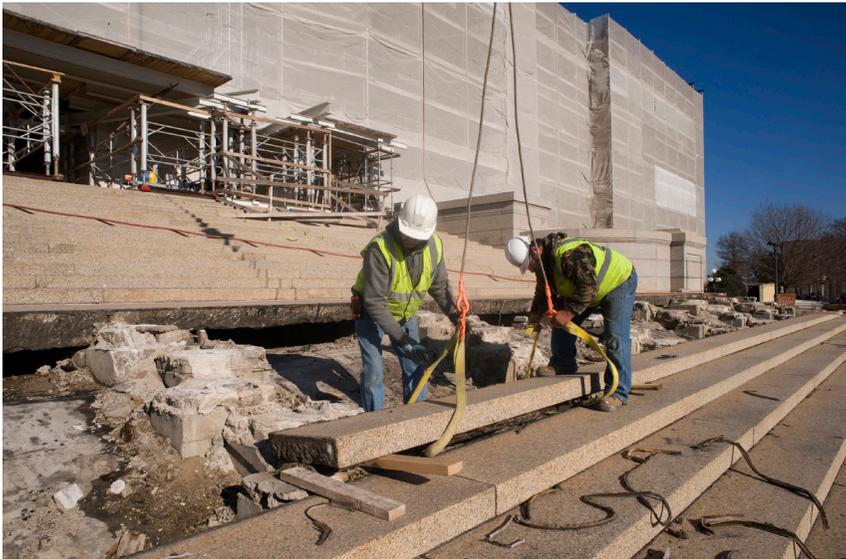
Deterioration of the waterproofing of the building resulted in water infiltration into the Capitol, while crumbling structural walls supporting the steps required extensive repairs. Each solid granite tread on the front, east, and west steps to the Capitol was temporarily removed, stored, and then reinstalled back in its original location after foundation and waterproofing repairs were completed.

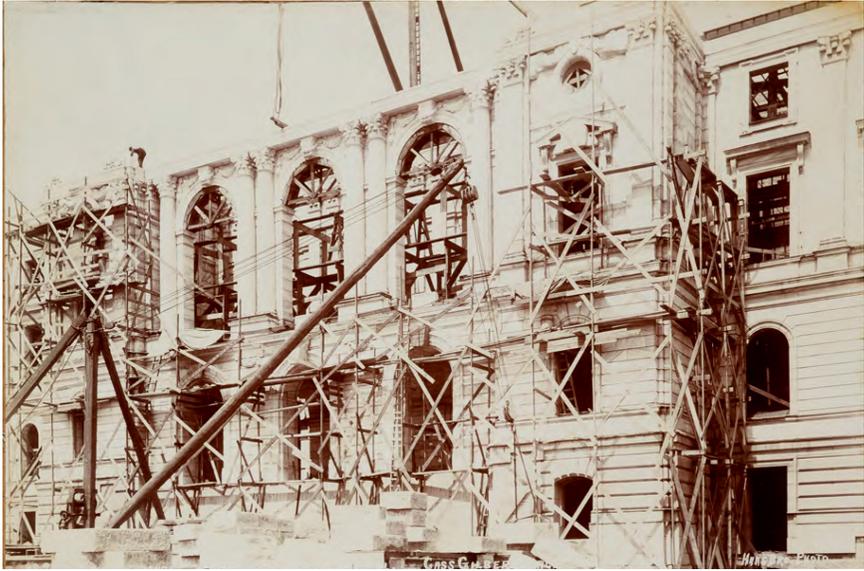
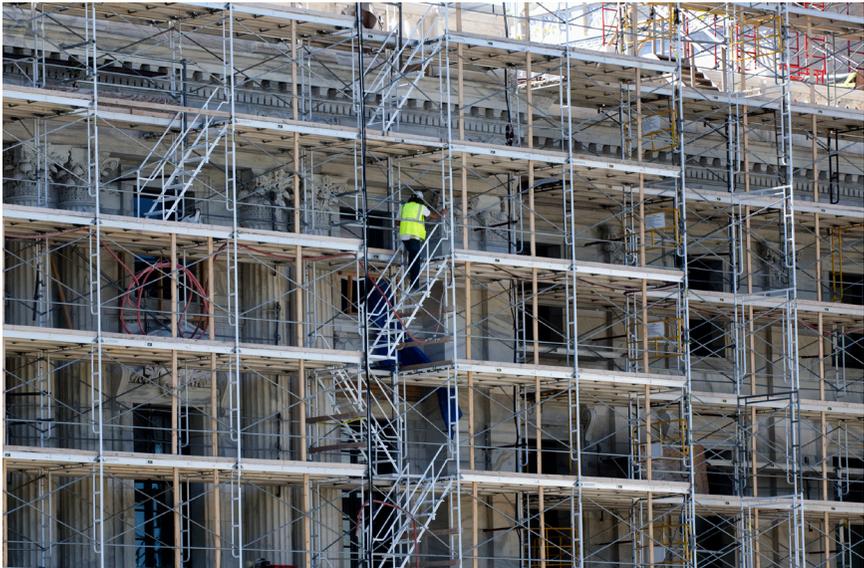
Scaffolding was installed on one face of the building at a time to allow for stone investigation, repair, and replacement work. While the materials have changed and safety has improved, the basic concept of scaffolding as the best way to affect exterior repairs remains the same today as it was over 100 years ago. Some records indicate that six people died on the jobsite during the original construction of the Capitol.

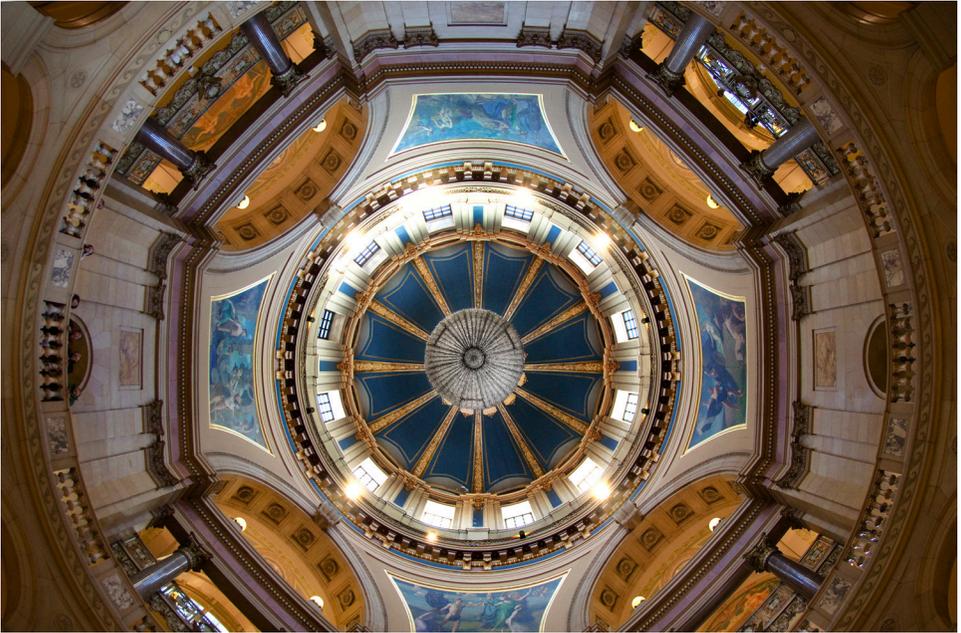
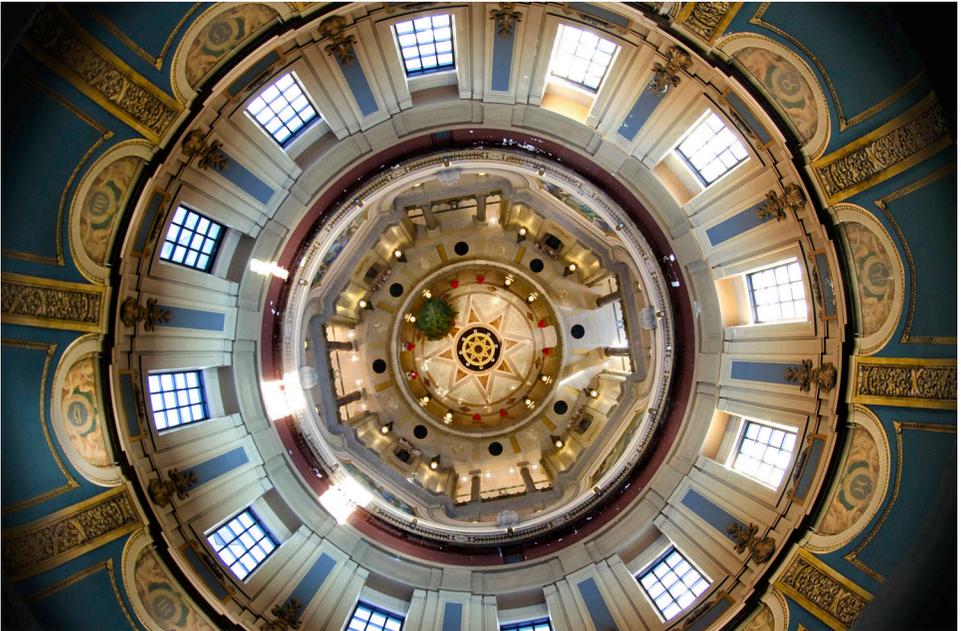
These two views, one looking up to the ceiling of the rotunda (top); and the other looking down to the first floor before repair and restoration work began (below).

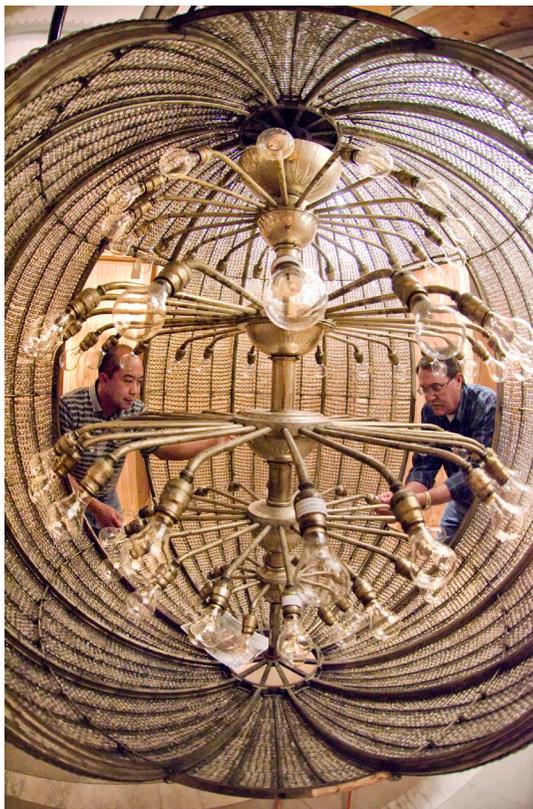
Lighting restorers are shown rewiring the rotunda chandelier in 2012. The large light fixture is six foot in diameter, has 92 light bulbs over 48,000 glass beads and weighs approximately a ton. The chandelier is on an electric winch system that allows for it to be lowered for cleaning and maintenance.

Modern LED lighting with a vintage appearance has replaced old-fashioned bulbs throughout the Capitol building, saving energy and labor costs.

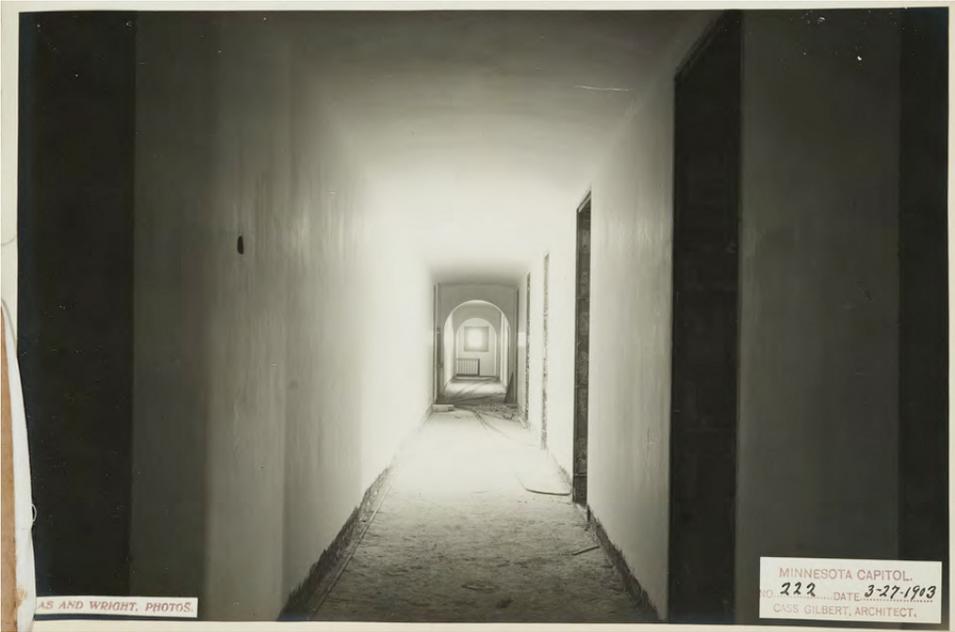
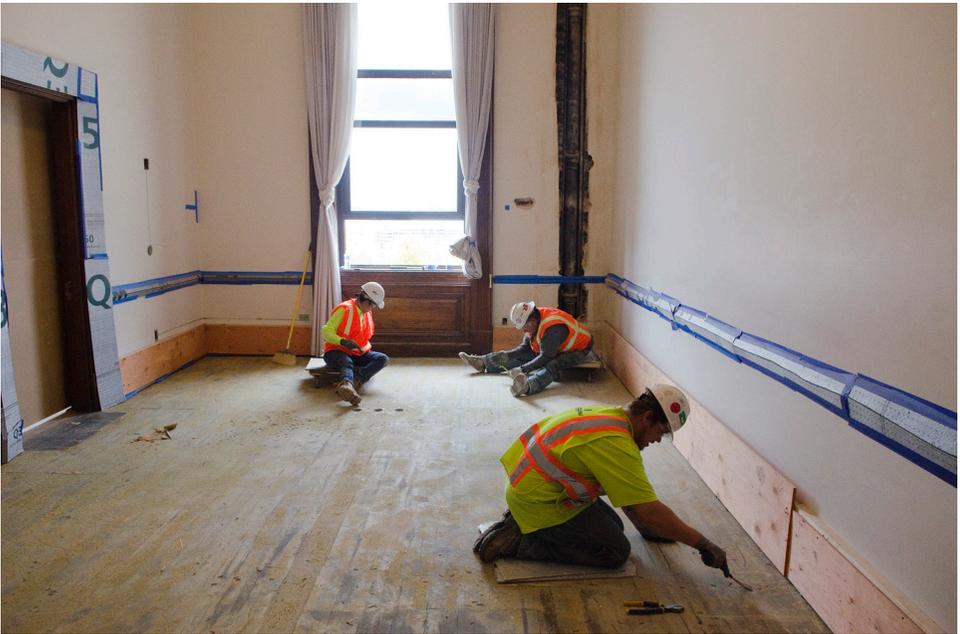
Above, an unfinished Capitol office hallway in 1903. Below, workers have exposed the original hard wood floor of the offices in the Capitol.

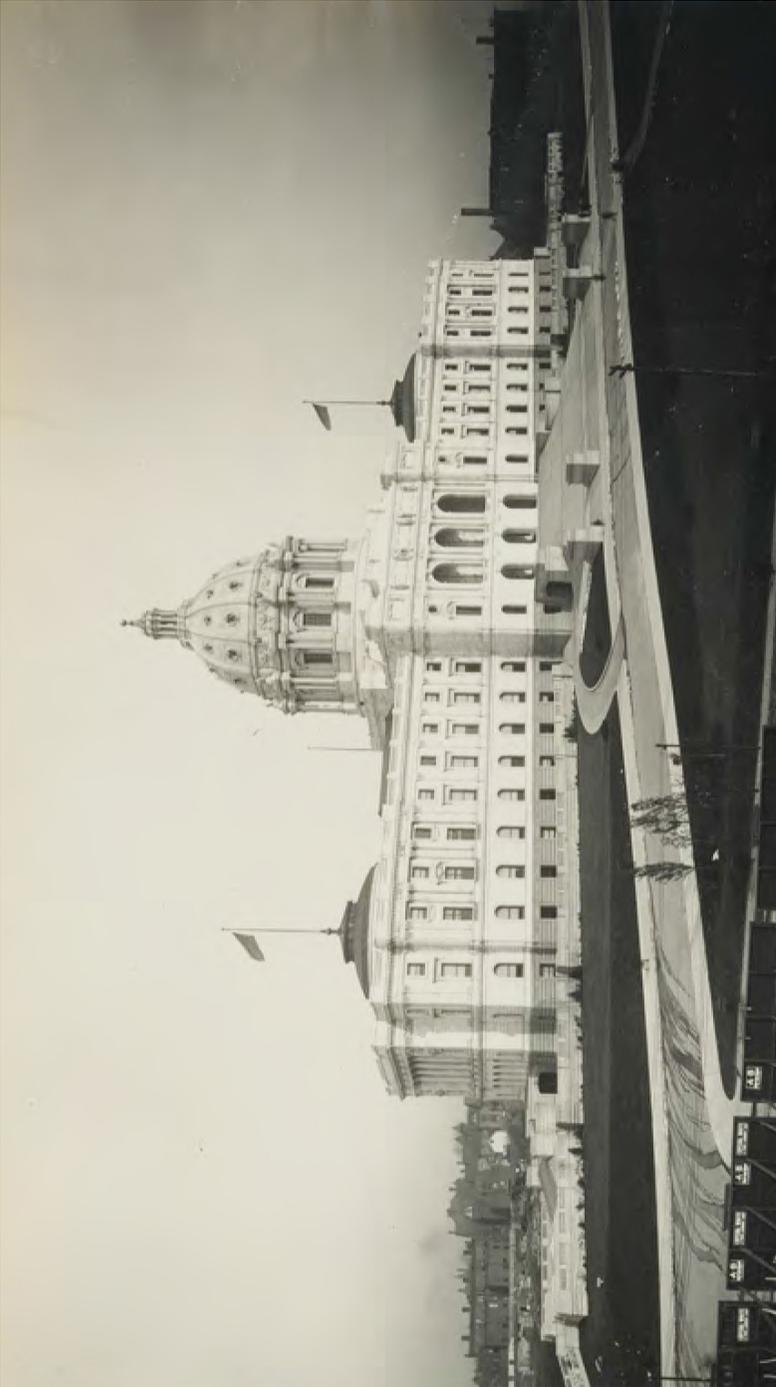
Shown is the Capitol in its completed state, except for the golden Quadriga. The Quadriga was placed in 1906, one year after the Capitol opened. The lower levels and stairs of the building (darker in color) were made of granite from central Minnesota. The remainder was marble quarried in Georgia and shipped to St. Paul. The photo also depicts Cass Gilbert's original vision, which inspired the Restoration plan, for the pedestrian promenade and landscaping.

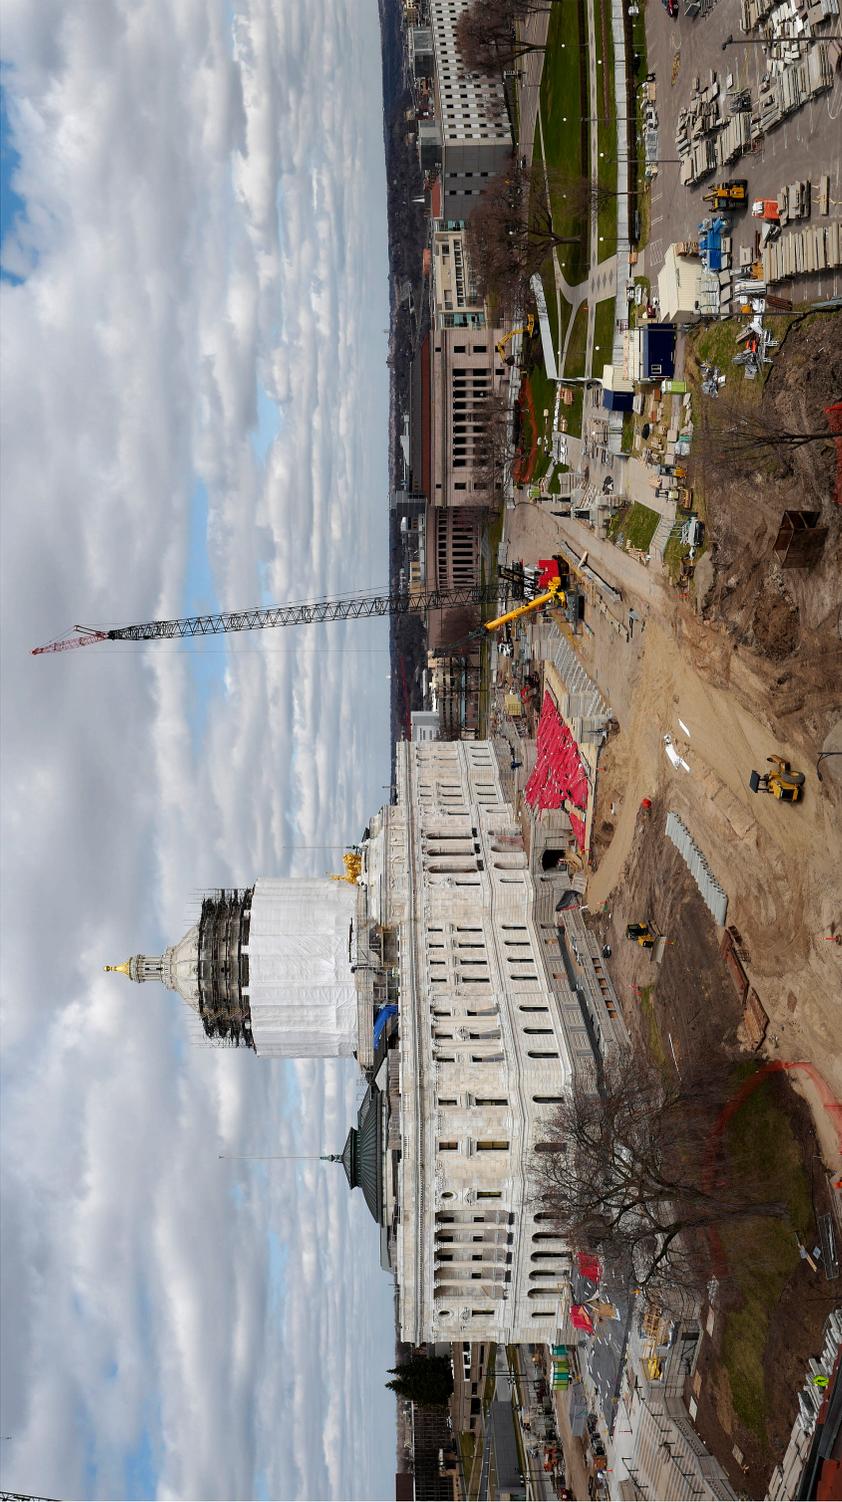
Aurora Avenue, the asphalt street, and parking were removed from the south side of the building to create a pedestrian promenade to link the Capitol to the Upper and Lower Mall.
